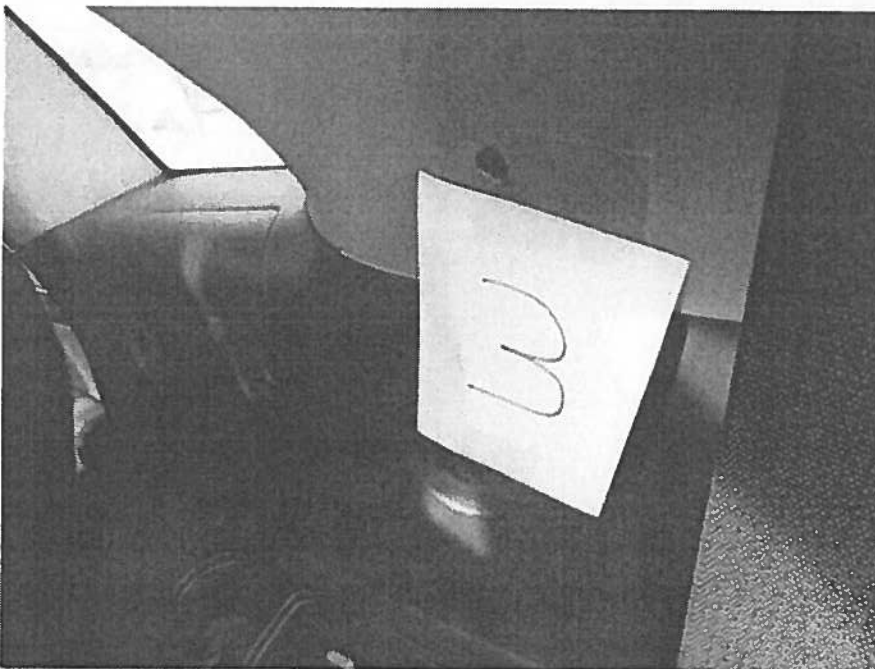
Bullet Strike #3 Was located on the rear passenger side of plastic side panel. This was above the level of the 3rd row seating headrests and seat. There was not an exit. The projectile was not located or recovered by us. Unknown if the OSBI discovered it or recovered projectile. This strike also appeared to be west to east trajectory. This round could only have come from the deputy.

Bullet strike on passenger side interior wall in rear of vehicle. This round was inbound and possibly struck back glass which was shattered. Deputy could be only source for this round.

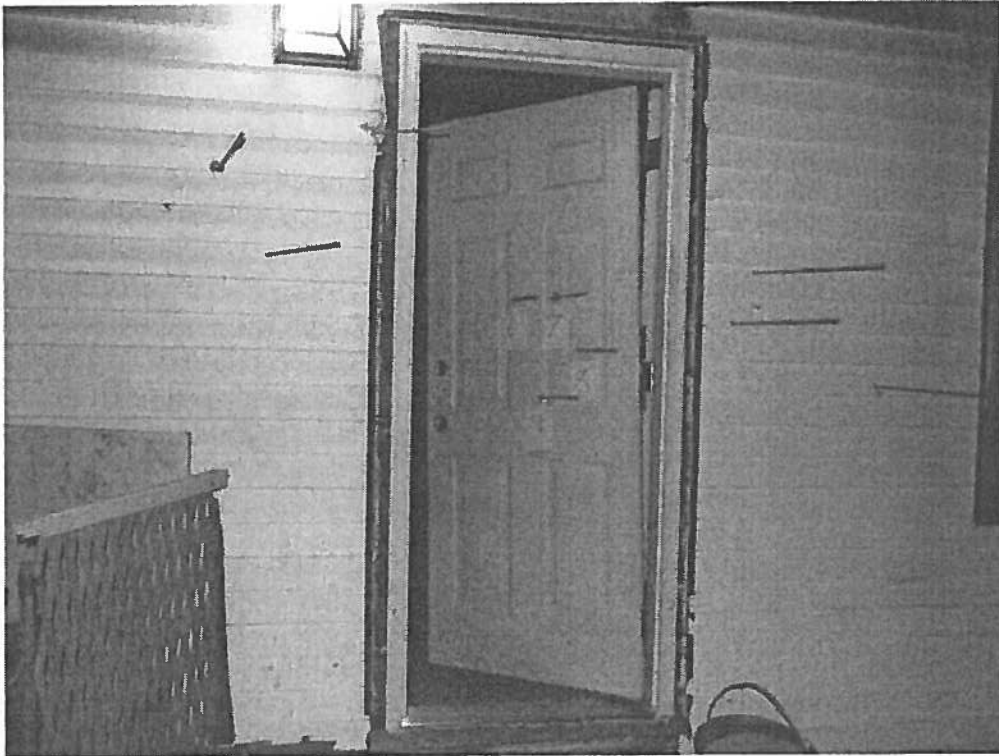
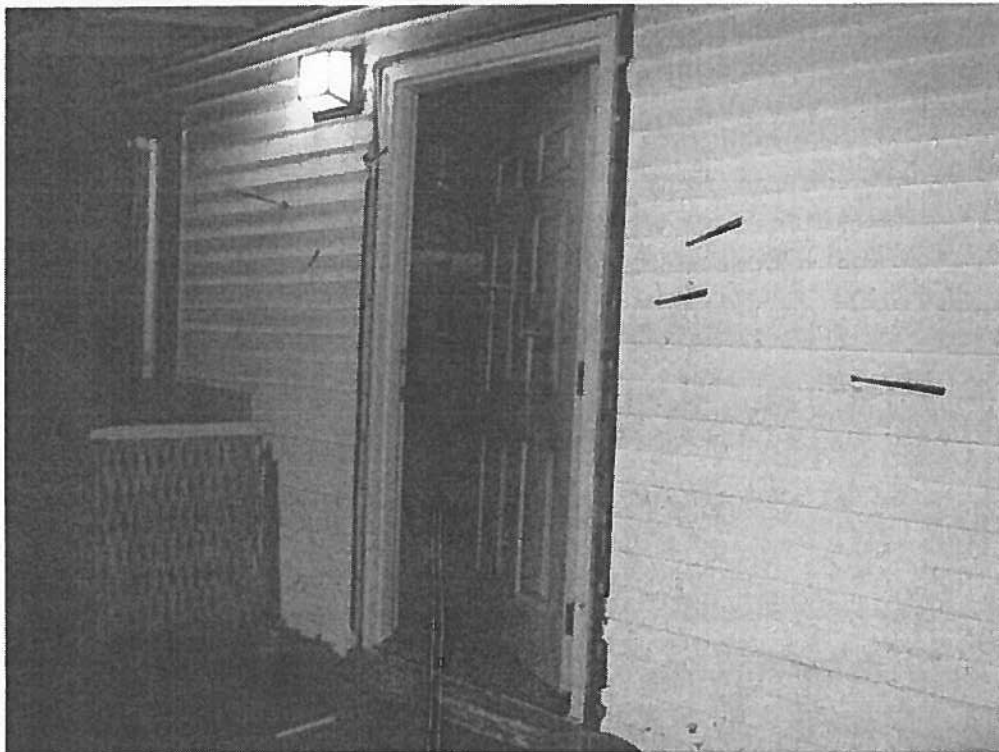
Trajectory paths prove that door had to be shut at the time of the shooting.
